EPOXYTEC™

Grease Trap Rehab and Lining

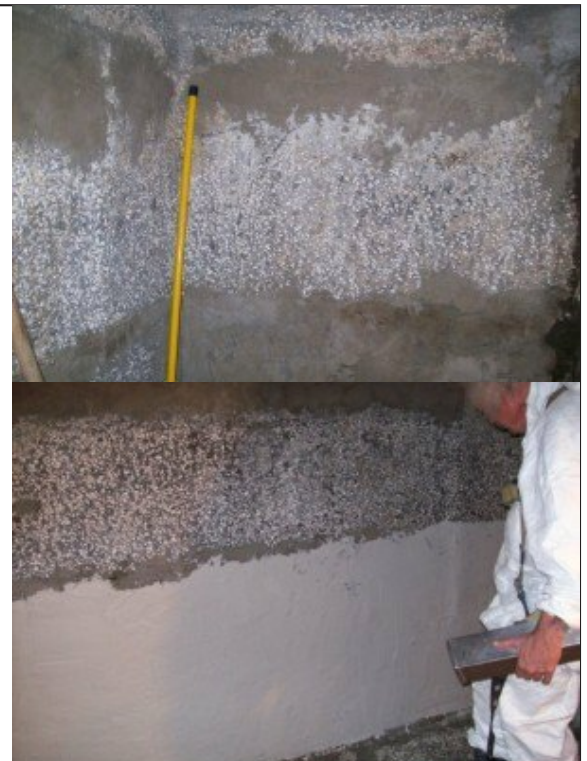
A Vac Truck was utilized to drain and dispose of the grease accumulated in the trap, and a bypass pump system was put into place. The constant accumulation of grease retains sulfuric acid, and the waste becomes very corrosive, eventually causing the breakdown and deterioration of the porous concrete in the structure, as you can see below.
