# CASE STUDY SERIES

**PROJECT:** City of Riviera Beach

**DATE:** September 2017

## Riviera Beach Lift Station Rehabilitation

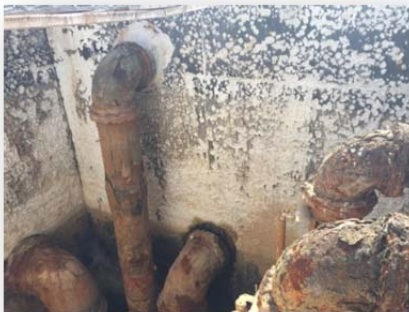
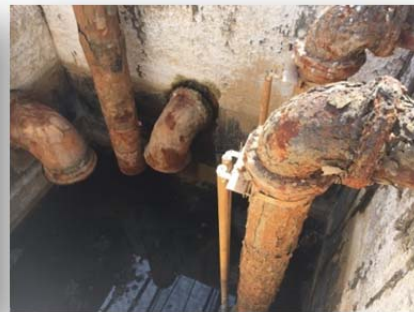
This concrete lift station measuring approximately 15' x 15' x 30' deep was severely deteriorated and included areas of rebar exposure. Some areas had clear rust stains or bleeding, while others had definite rebar exposure. The lift station was in need of restoration and protection.

The first step to rehabilitating this lift station was to restore the surface using Mortartec Ceramico, particularly in the rebar-visible areas where rust was observed. First a hydroblast was required to achieve a profile to ICRI of 2-3 prior to applying the repair materials. Mortartec Ceramico was used to seal off any moisture and arrest the corrosion.

Immediately after the application of the Mortartec Ceramico, two coats of Epoxytec's Uroflex at 20-25 mils each for a total of 40-50 mils DFT was recommended for the floors, walls, and ceiling slab. Uroflex is a urethane-epoxy hybrid providing structural integrity and chemical resistance.

Epoxytec's UME system uses one coat of Ceramico and two coats of Uroflex on the walls, ceiling, and floor. In addition, the pipes were replaced, coated with Uroflex, and sealed at the joint with CPP where the pipes meet the wall.

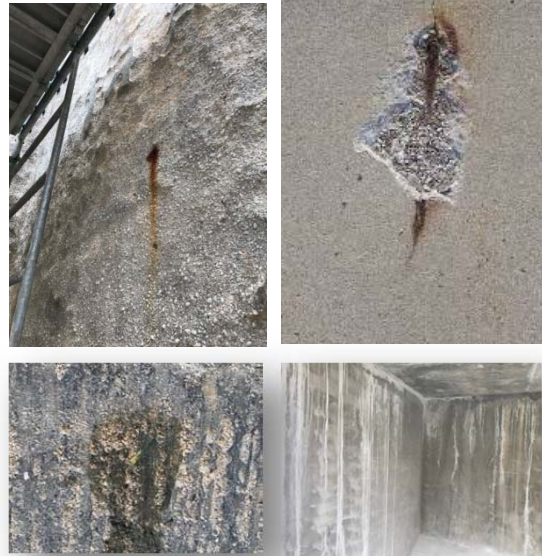
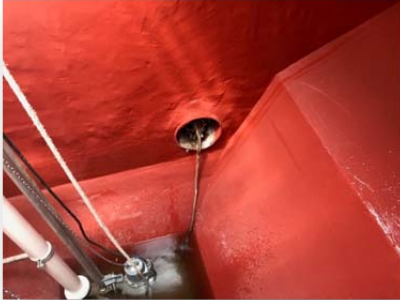
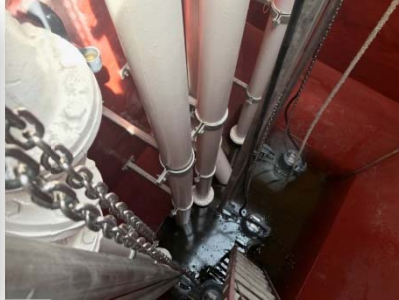
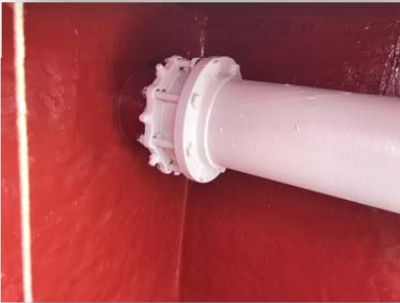
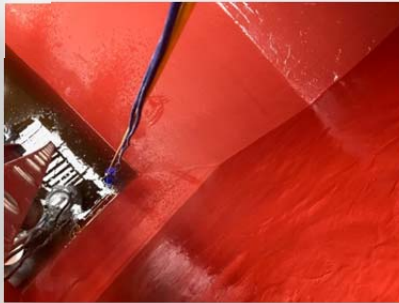
The project was successfully completed in September 2017. Throughout the process, several inspections took place, including pH and sound testing as well as a third-party spark test (holiday detection test). The final test showed that there were no holidays detected within the entire structure, a rare occurrence attesting to the quality of the coating application.

Epoxytec's UME system was applied according to specification. The application was completed skillfully, and the product cured well throughout.
