# CASE STUDY SERIES

**PROJECT:** Rehabilitation of Digester, Including Crack Repairs  
**CONTRACTOR:** Carlson Young  
**ENGINEER:** LAN Inc.  
**LOCATION:** Texas  
**DATE:** Spring 2018  
**PRODUCTS:** Epoxytec CPP™ Sprayliner and CPP™ Trowelable

## Solutions for Tricky Infrastructure Crack Repairs

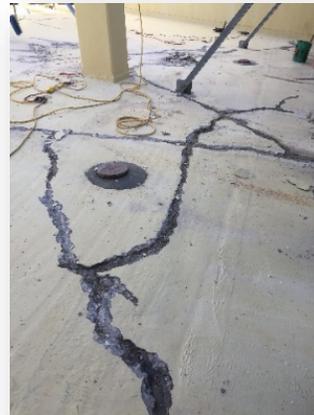
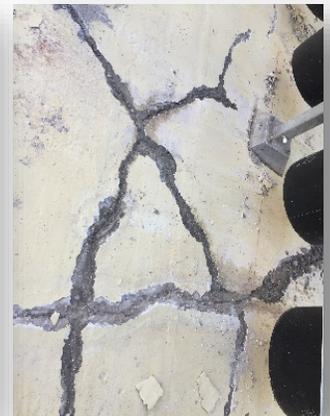
This digester located in Texas was showing severe deterioration, including deep cracks along the floor that were leaking water in areas throughout the unit. The number of cracks and leaks suggested that the water membrane underneath the slab may have aged and fatigued. Epoxytec recommended a combination of CPP Sprayliner and CPP Trowelable. CPP has been used to rehabilitate water/wastewater infrastructures throughout the country for the last three decades. It is an effective method for preventing corrosion and addressing deterioration in a single system.

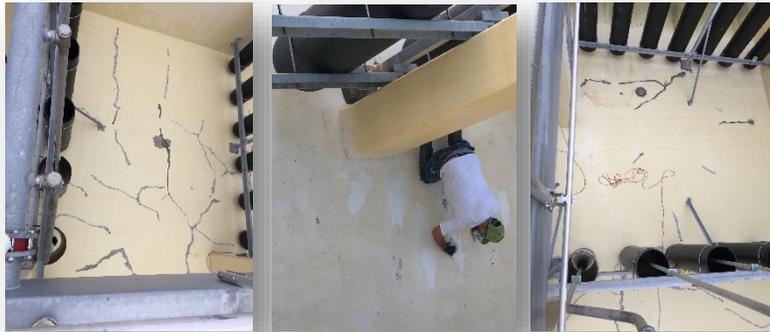
Filling in cracks using CPP trowelable

After allowing the initial coat to cure, drilling on some major leaking areas was conducted to alleviate pressure away from the cracks. Next, standard CPP was applied to these open cracks to finalize the repairs (now with no pressure).

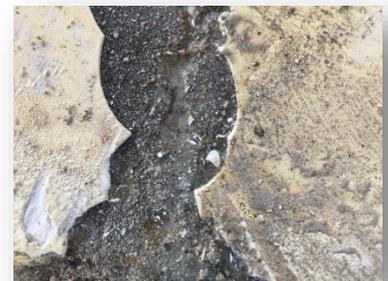
Cracks drilled to relieve water pressure

Once the majority of the cracks were sealed and repaired and the material was cured, the contractor grouted the relief drill holes and patched them with CPP trowelable. The final step included spraying a coat of CPP Sprayliner to make all the surfaces uniform.
