EPOXYTEC™

Aeration Chamber Rehabilitation

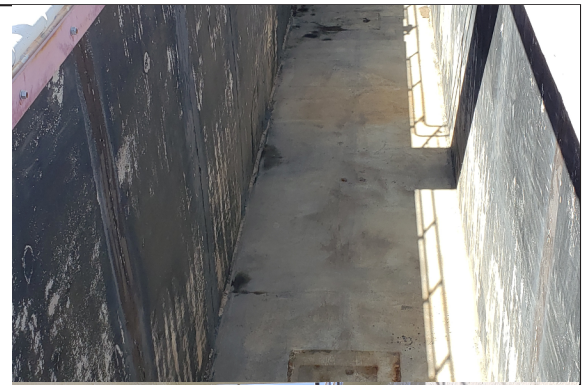
CPP Sprayliner

CPP Sprayliner served as the protective coating system, which is a structural protective liner that was spray-applied over the entire surface of the concrete. Epoxytec CPP Sprayliner is a two-component, moisture-insensitive, highly adhesive, chemical-resistant FRP coating. This 100% solids, high-strength and reinforced epoxy was an ideal choice for the severely deteriorated concrete.

CPP Sprayliner was then applied using a high-pressure, heated plural component spraying at 125 mils min. as a high build, fiber-reinforced protective (FRP) liner.

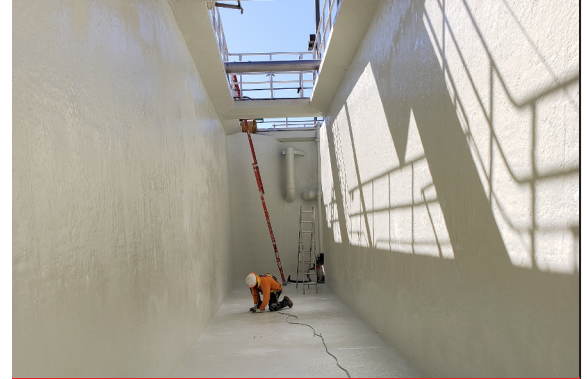
Mortartec Ceramico

Mortartec Ceramico is a balance of Portland cement cured with epoxy; and also incorporates hardened ceramics, graded silica aggregate, synthetic fibers and silica fume that produces one of the most coveted mortars in the industrial market today. Mortartec Ceramico was used for the structural patchwork.

The surfaces were approved with acceptance of cleanliness and profile. Installation could proceed, but first with repair methods. To patch and address repairs, Mortartec Ceramico was applied by hand.
