Solutions for Tricky Infrastructure Crack Repairs

Structure Digester

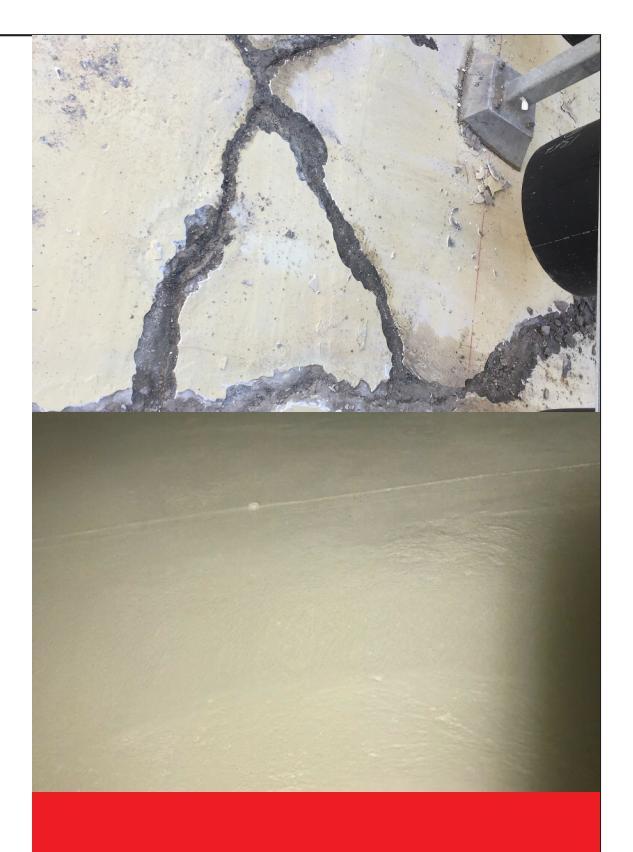
This digester located in Texas was showing severe deterioration, including deep cracks along the floor that were leaking water in areas throughout the unit. The number of cracks and leaks suggested that the water membrane underneath the slab may have aged and fatigued. Epoxytec recommended a combination of CPP Sprayliner and CPP Trowelable. CPP has been used to rehabilitate water/wastewater infrastructures throughout the country for the last three decades. It is an effective method for preventing corrosion and addressing deterioration in a single system.

After allowing the initial coat to cure, drilling on some major leaking areas was conducted to alleviate pressure away from the cracks. Next, standard CPP was applied to these open cracks to finalize the repairs (now with no pressure).

Once the majority of the cracks were sealed and repaired and the material was cured, the contractor grouted the relief drill holes and patched them with CPP trowelable. The final step included spraying a coat of CPP Sprayliner to make all the surfaces uniform.
