## Continual Manhole Rehabilitation Helps Utility District Avoid Replacements

### Project Information

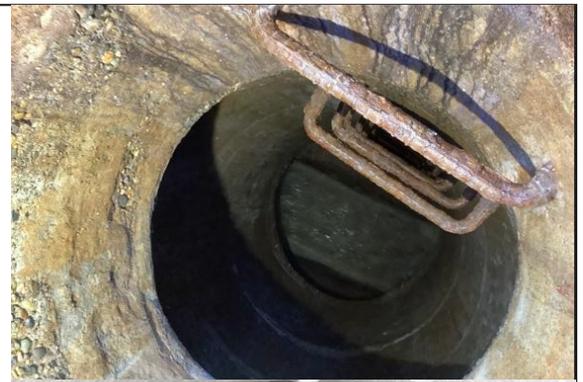
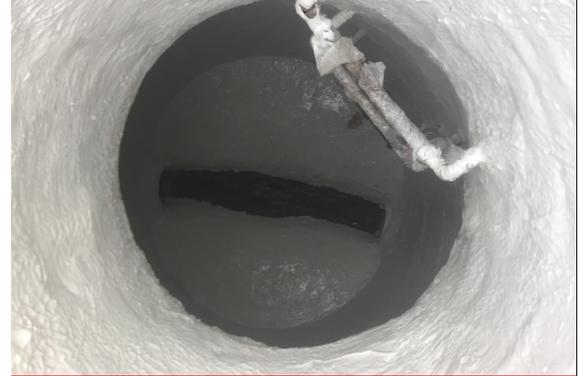
Recently, Lakehaven restored 70 precast concrete manholes (860 vertical feet) that were exhibiting medium to heavy deterioration with exposed aggregate. Having completed various projects throughout the past three years for the Lakehaven Utility District, including 102 manhole rehabilitations, applicator Pro-Vac had the extensive experience necessary for successful manhole rehabilitation. Pro-Vac was well prepared to assist the city in finding an epoxy coating solution that would provide protection against corrosion caused by high levels of H<sub>2</sub>S.

Prior to surface preparation, Pro-Vac took measures to protect the flow lines, then removed all material from the inside of the structures and pressure washed the interior. On the heavily deteriorated structures, Epoxytec's Silicate, a cementitious base coat, was applied to create a smooth finish. Once cured, the structure was pressure washed again, and CPP Sprayliner was applied at 120 mils. Spark tests and a pull test were used as a final measure to ensure proper application.
