Structural Epoxy Lining System Restores Culvert Pipe Integrity

In November 2013, a large-diameter steel culvert (78"–90") located in Syracuse, New York needed attention before it reached the end of its life cycle. The culvert was part of a storm draining system that was aging and deteriorating due to seasonal high flow and freeze/thaw cycles. The pipe's original galvanic zinc protection was nearly gone, leaving the surface exposed to oxidation.

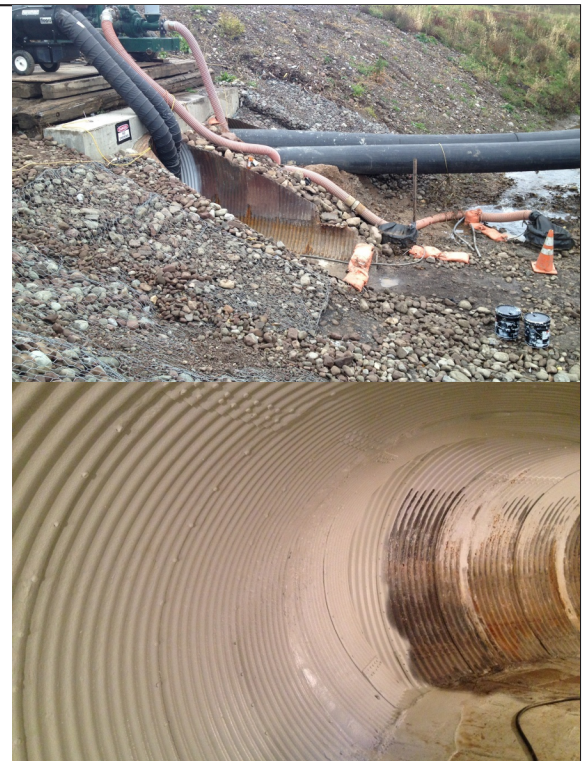
CPP Sprayliner (formerly CPP Sprayable)
