Leaks in your lift station? Epoxytec has the solution.

Project Information

Location Alberta Lea, Minnesota

Structure Lift Station

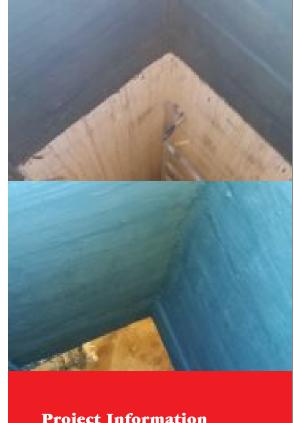
The Problem: Located in Alberta Lea, Minnesota, about 90 miles south of the Twin Cities, three lift stations needed rehabilitation for a variety of reasons. To begin with, water was penetrating through the mortar joints and concrete blocks, causing their coatings to delaminate. These leaks allowed inflow and infiltration (I&I), an unnecessary and ultimately costly problem for any city's utility department. Next, the lift stations had groundwater seepage into the structures, which was contaminating electrical equipment.

These dry side access hatchway lift stations built of concrete blocks required a system that would plug the leaks as well as reseal and protect the surface from future damage.

Product Application: Fieldstone Services, the contractor for this project, began with proper surface preparation, using a 4" Metabo right-angle grinder fitted with a Joe Due shroud & vacuum attachment in order to remove all oil, dust, grease, dirt, loose rust, and other foreign material, to ensure adequate adhesion of the coatings. Mortartec Cladliner was mixed and hand-troweled at 1/4".
