When it Comes to Rehabilitation, Mortartec Cladliner is a Hole in One

Greenwich, Connecticut

Concrete Septic Tank

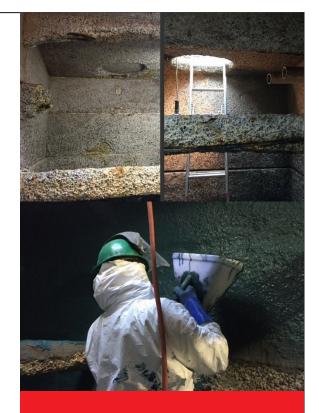
Product Application: The surface preparation of the structure was like that of other coatings. A high-pressure blast with an oscillating nozzle removed any loose debris from the substrate before using a repair mortar to patch the most severely deteriorated areas.

Mortartec Cladliner was then mixed in a 1:1 ratio and applied with an air gun in two half-inch coats to this $9' \times 16' \times 10.6'$ structure. The entire project from start to finish was completed over a three-day period using three applicators.
