## **Concrete Manhole Corrosion Solution**

## **Project Information**

**Structure**Sanitary Sewer Manhole

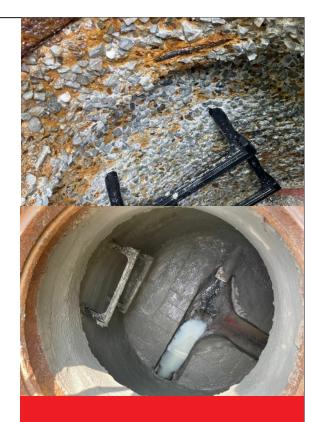
Corrosion was the culprit for this concrete manhole which required rehabilitation to stop the continual effects of Hydrogen Sulfide ( $H_2S$ ). Due to the severe condition of the manhole, including visible signs of deterioration and spalling concrete that compromised the structure, an emergency repair was deemed necessary.

Above: Sanitary sewer manhole rehabilitation before and after.

This particular rehabilitation began with surface preparation that included the removal of damaged concrete and abrasive blasting in accordance with SSPC-SP13/NACE No. 6 "Surface Preparation of Concrete." Using a heated, plural component system, Epoxytec's Series 456 CPP Sprayliner was spray applied. The CPP Sprayliner product produces a thick, microfiber-reinforced polymer (FRP) film with high mechanical strength to protect against corrosion and seal Inflow & Infiltration (I&I). It has excellent H<sub>2</sub>S resistance, sealing, moisture tolerance, and service wear durability, making it a go-to product for manhole rehabilitation.
