EPOXYTEC™

I&I Damage Resolved using CPP Sprayliner MH

Project Information

Sanitary Sewer Manhole

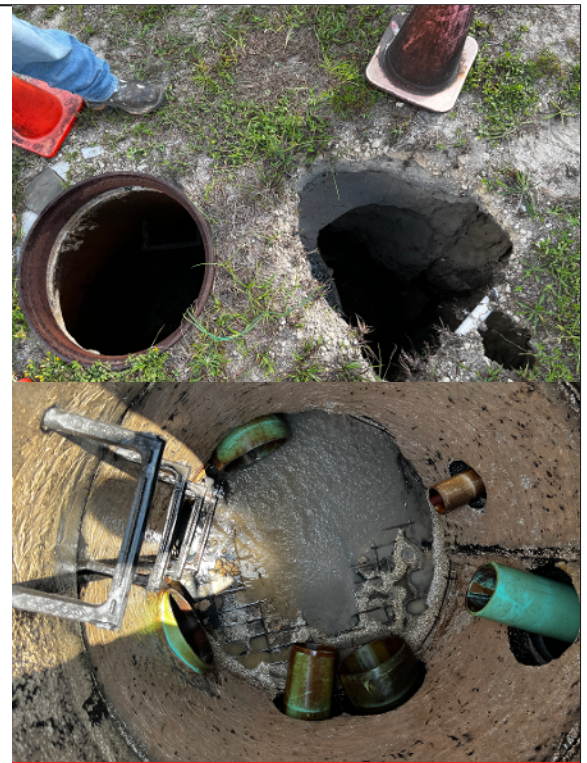
Above: City of Port St. Joe manhole and adjacent sinkhole

Manhole prior to surface preparation with visible pre-existing coating and rebar.

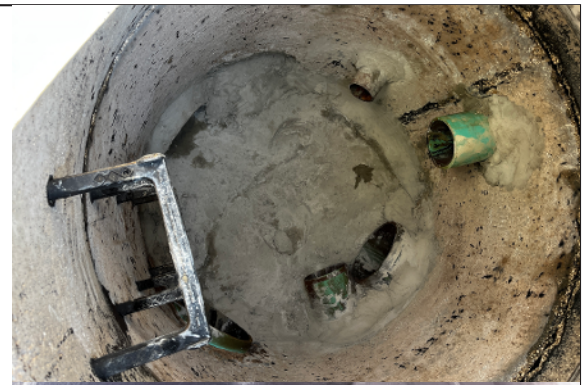
Above: Manhole after concrete restoration.

Rapid set grout was used to resurface the manhole floor, which was built up approximately 4" to the bottom of the inlet and outlet pipes. Once the grout was applied and allowed to cure for one hour, GCU began spray-applying Series 451 CPP Sprayliner MH to the manhole substrate at the recommended

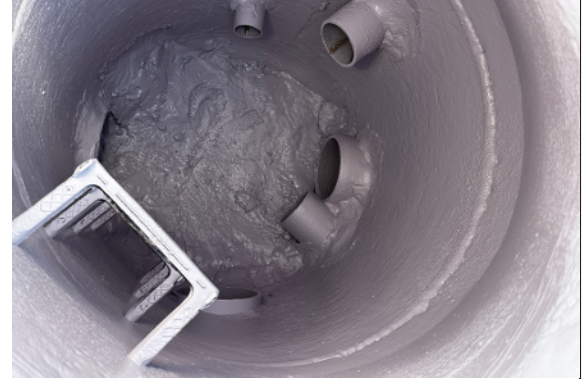
Manhole after Series 451 CPP Sprayliner MH installation.

dry film thickness (DFT) range of 125–250 mils. Due to the amount of damage experienced within this manhole, the spray application resulted in 200-250 mils DFT. Epoxytec's ECAN mobile spray unit was utilized for this application, with the pump operating at 2000 psi using a 525-spray tip (with a 0.025 orifice).
