## **Okaloosa County Infrastructure Renewal: A Comprehensive Sewer Rehabilitation Project**

The Okaloosa County Sanitary Sewer project, located Okaloosa Island, Florida, involved significant rehabilitation to improve the functionality and lifespan of the county's sewer infrastructure. As a coastal area, Okaloosa County experiences considerable inflow and infiltration (I&I) issues within its infrastructure. Completed in February 2025, the project specifically focused on addressing water infiltration and resurfacing the infrastructure's brick walls and cone sections, which were compromised by corroded mortar joints allowing groundwater infiltration.

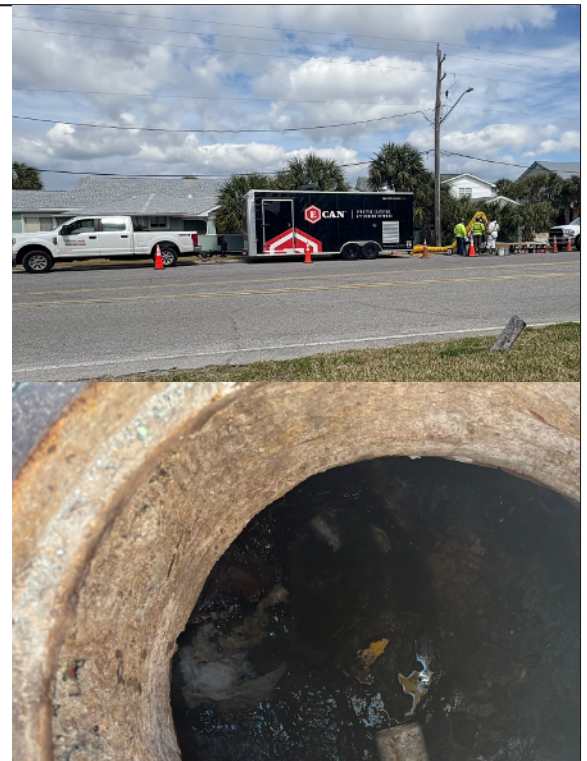
Bottom: Before image showing the deteriorated condition of the sanitary sewer manhole prior to rehabilitation

**Hydroxx-3** was used to stop active water flow from seeping into the structure due to the compromised mortar joints. Since the leaks were not high-pressure, no chemical grout was necessary.

**Mortartec Silicate** filled the mortar joints, resurfaced the brick

substrate, and smoothed out irregularities caused by staggered bricks. It also filled foundation joints and pipe seams and was used to rebuild the bench and refurbish the invert channel.

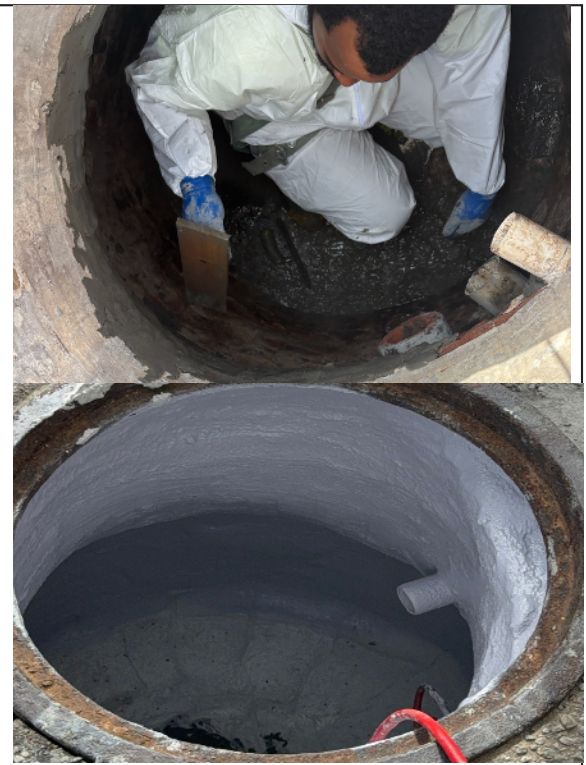
Top: Application of Mortartec Silicate to fill mortar joints and create a smooth, uniform substrate for subsequent protective coatings.

Bottom: After image showing the successfully rehabilitated sanitary sewer manhole

**CPP Sprayliner MH** was applied to the walls to provide additional protection and ensure a quick return to service, minimizing downtime and allowing the infrastructure to resume operation swiftly and efficiently.

The substrates involved in the project included brick and precast concrete. Surface preparation was carried out in compliance with SSPC SP13/NACE 6 and ICRI CSP 4 standards, ensuring a strong bond for the applied products. Despite the challenging conditions, such as deteriorating mortar joints and the need for precision application, the team's use of advanced Epoxytec products enabled them to achieve long-lasting protection, extending the service life of the infrastructure.
