EPOXYTEC™

Mitigating Groundwater Intrusion at Chilton Reservoir

Concrete potable water reservoir
(Partially buried)

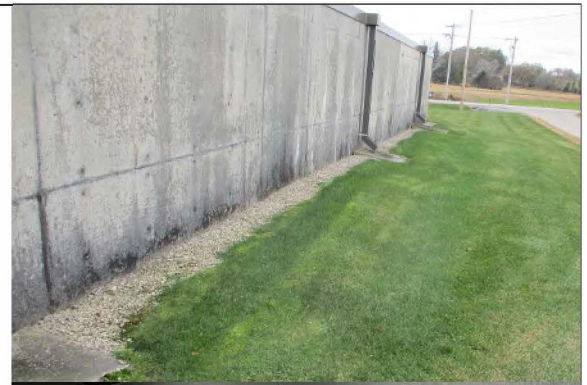
Above: Exterior side view of Reservoir No. 8, providing scale and orientation of the structure.

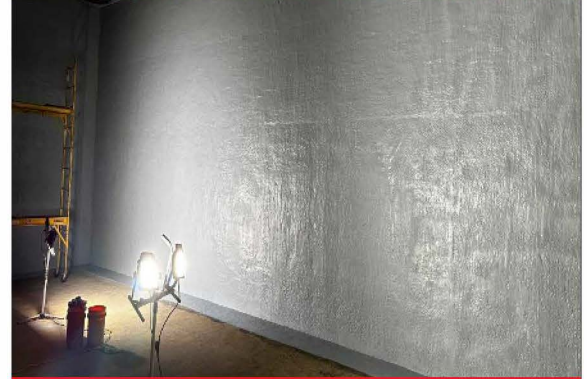
Below: Freshly applied Epoxytec Series 457 (CPP Sprayliner 61) curing on the interior reservoir walls, following spray-and-back-trowel application to achieve a uniform finish throughout the structure.

Before work could begin, the applicator had to remove the existing coating, which proved extremely rubbery and difficult to blast off. A combination of pressure washing, grinding, abrasive blasting, and SSPC-SP13 / ICRI-CSP5 surface preparation methods were required. The concrete itself was old, with many high and low spots, and there was concern that continued blasting could damage it further. Some low-lying areas still held remnants of the original coating, eventually leading the contractor to complete test patches using Tnemec Series N140F to ensure the system could proceed without compromising the substrate.
